## 2. MAINTENANCE OF PROJECT FEATURES

### 2.1 Introduction

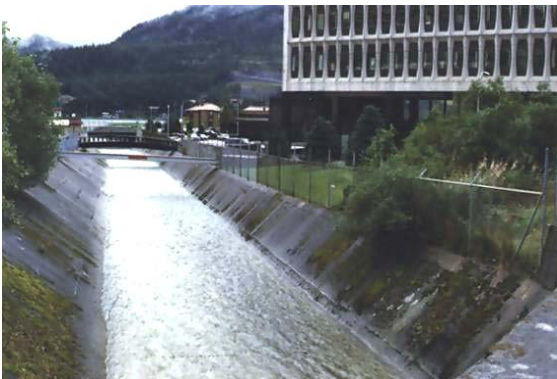
**Figure 2.74** *ACCEPTABLE* concrete lined channel. (AK)

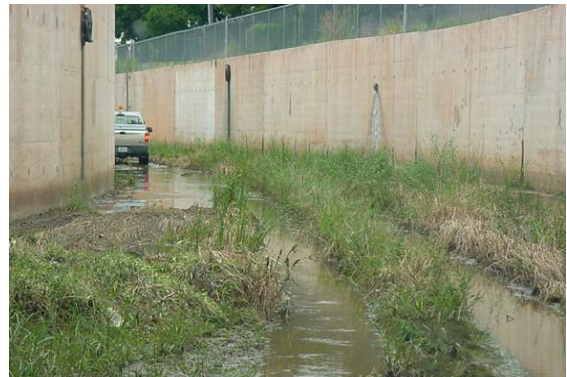
**Figure 2.75** *UNACCEPTABLE* vegetation and extensive sediment in channel. (TX)
